SALEM UNITED METHODIST CHURCH CLASSROOM # 5

MOLD REPORT

MID ATLANTIC JOB NUMBER:
MCOM-23-33

OCTOBER 2023

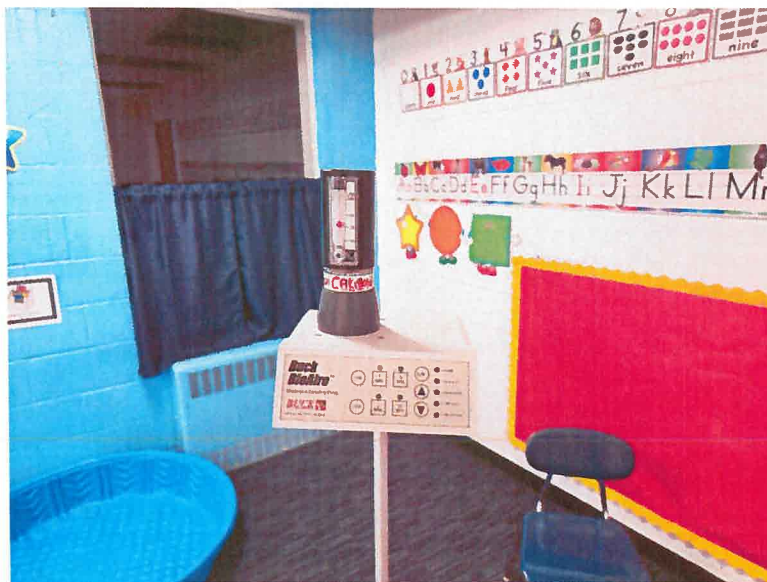
Photo #2:	Calibration of Pump – 15 lpm
-----------	------------------------------

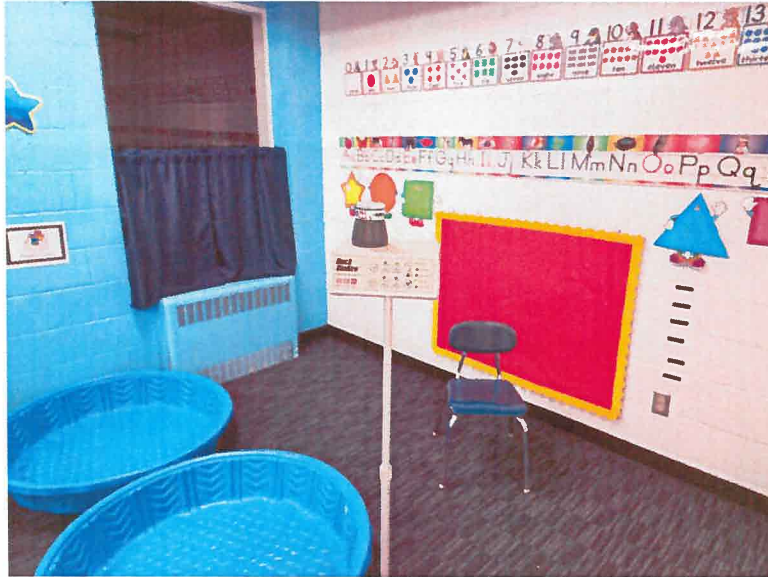
Photo #3:

M-1 - was collected from Classroom #5; revealing a total fungal spore count of 973; the most predominant fungi recovered was *Basidiospores*.

The inside air sample M-1 (Classroom #5) has a very low fungal counts and are comparable to the outside reference sample, indicating acceptable fungal ecology in the classroom area according to EPA and other industry guidelines.

Mold Air Sample M-1 – Classroom #5

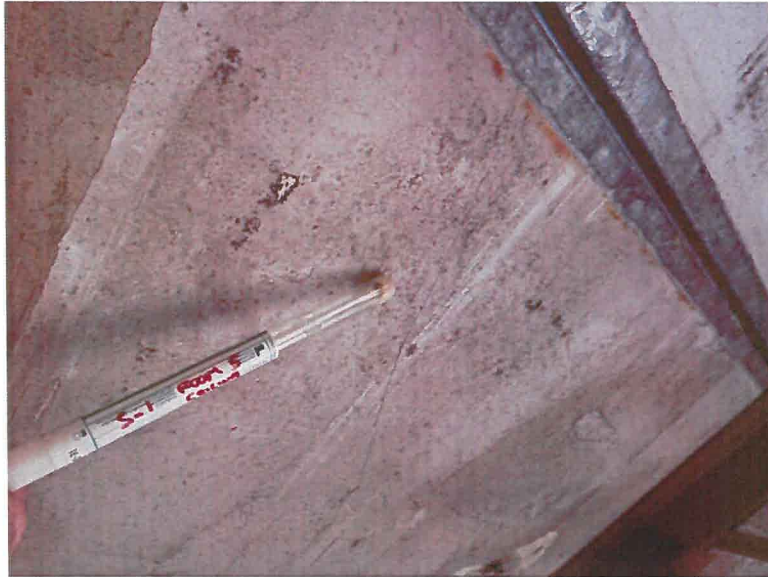
Photo
#5:

Sample S-1 was collected from Classroom #5 - Ceiling revealing: **NO FUNGI DETECTED.**

The mold surface swab sample results confirms NO MOLD GROWTH on the sampled area. No further action is warranted.

Mold Surface Sample S-1 – Classroom #5 Ceiling

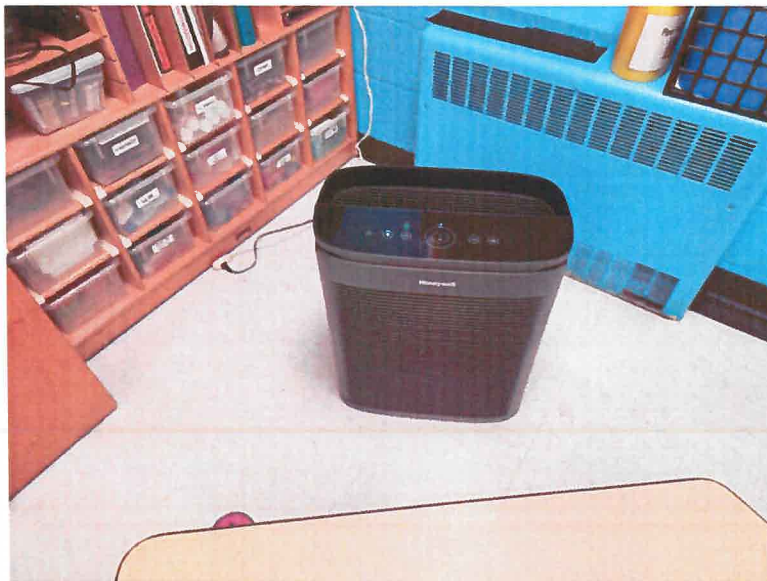
Photo
#6:

View of Air Cleaner Operating in Classroom #5

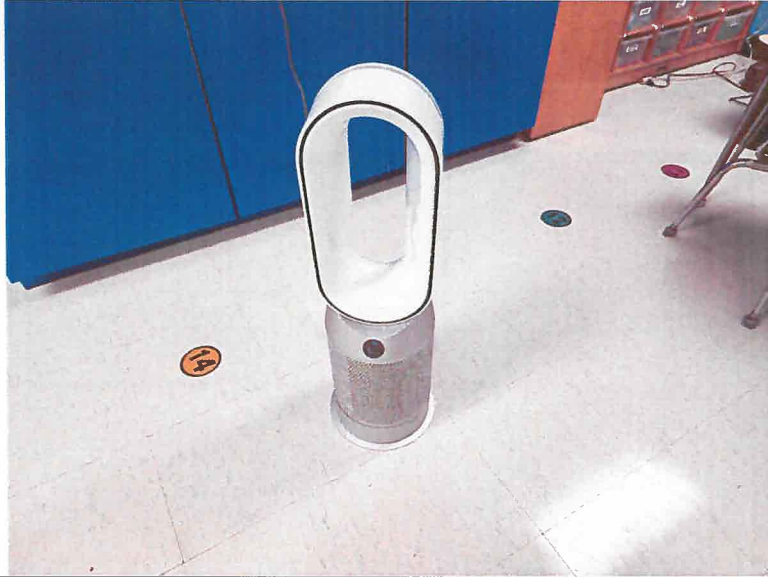
Photo
#7:

View of Air Cleaner Operating in Classroom #5
